Condition of the work on the new Capitol at Albany, N.Y., photograph 63

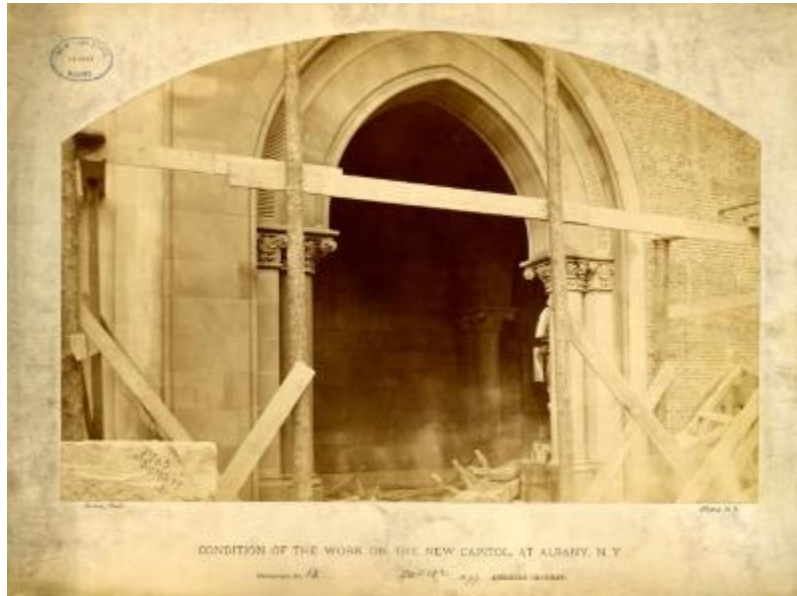
A view of an archway during the early construction of the New York State Capitol building in Albany, New York. The photograph was taken on October 18, 1877.
