## Crooked Lake Canal Survey, Milo showing two views of Canal and Henderson

NYSA\_A0848-77\_MC7\_DR14\_V14\_CRL\_8

1834

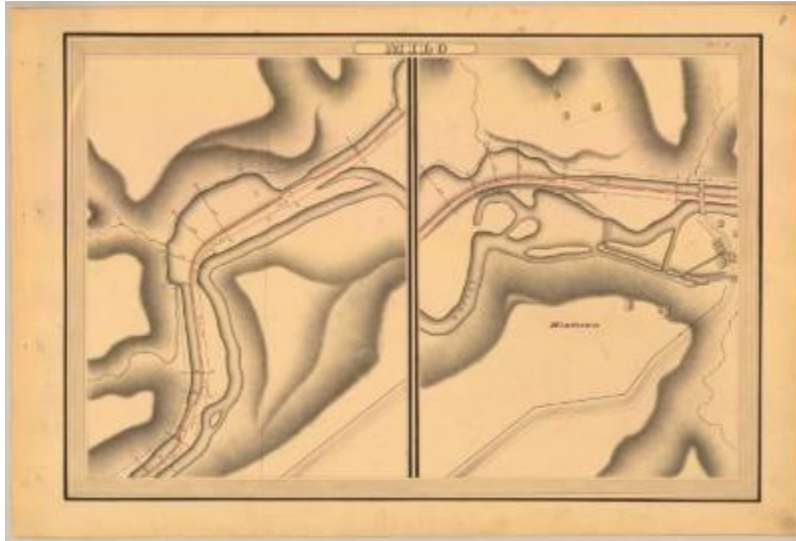
This is an ink, wash and charcoal map of a section of the Crooked Lake Canal in Milo. The map is split into two views. The first view shows a wide basin and an outlet stream. The second view shows, three bridges, twelve buildings, an unidentified road and an outlet stream branching off into mill runs. The red lines indicate courses and distances. The blue lines indicate canal right-of-way. The map also shows the property of Henderson.
