Chenango Canal Survey, Chenango showing two views of the Canal, Lock No. 106 and Chenango River

NYSA_A0848-77_MC8_DR1_V17_CHEN2_140

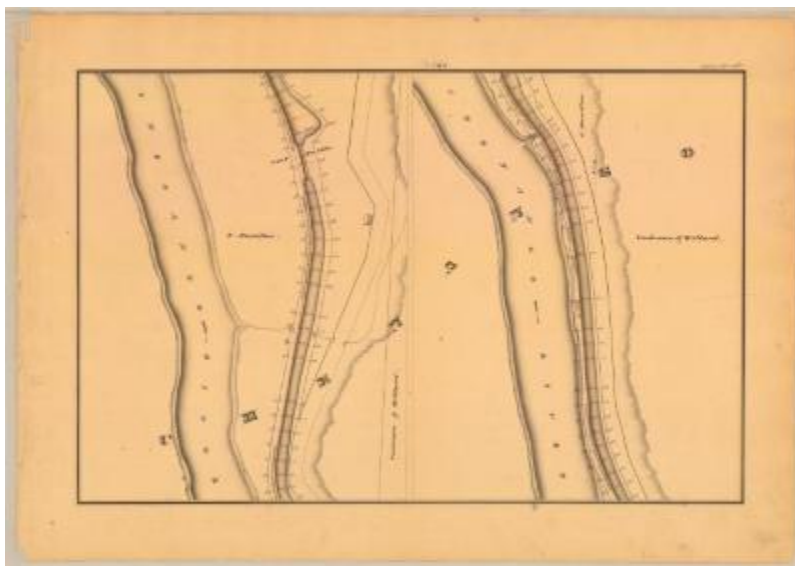
This is an ink, wash and charcoal map of a section of the Chenango Canal in Chenango. The map is split into two views. The first view shows the Chenango River, a stream that runs under the canal through a culvert and into the river, a large basin, Lock No. 106, a building and an unidentified road. The second view shows the Chenango River and a point where the river connects to the canal. The red lines indicate courses and distances. The blue lines indicate canal right-of-way. The map also shows the properties of G. Hamilton, Cushman and Willard.
